# Scaffold Event

## Where did it go wrong?

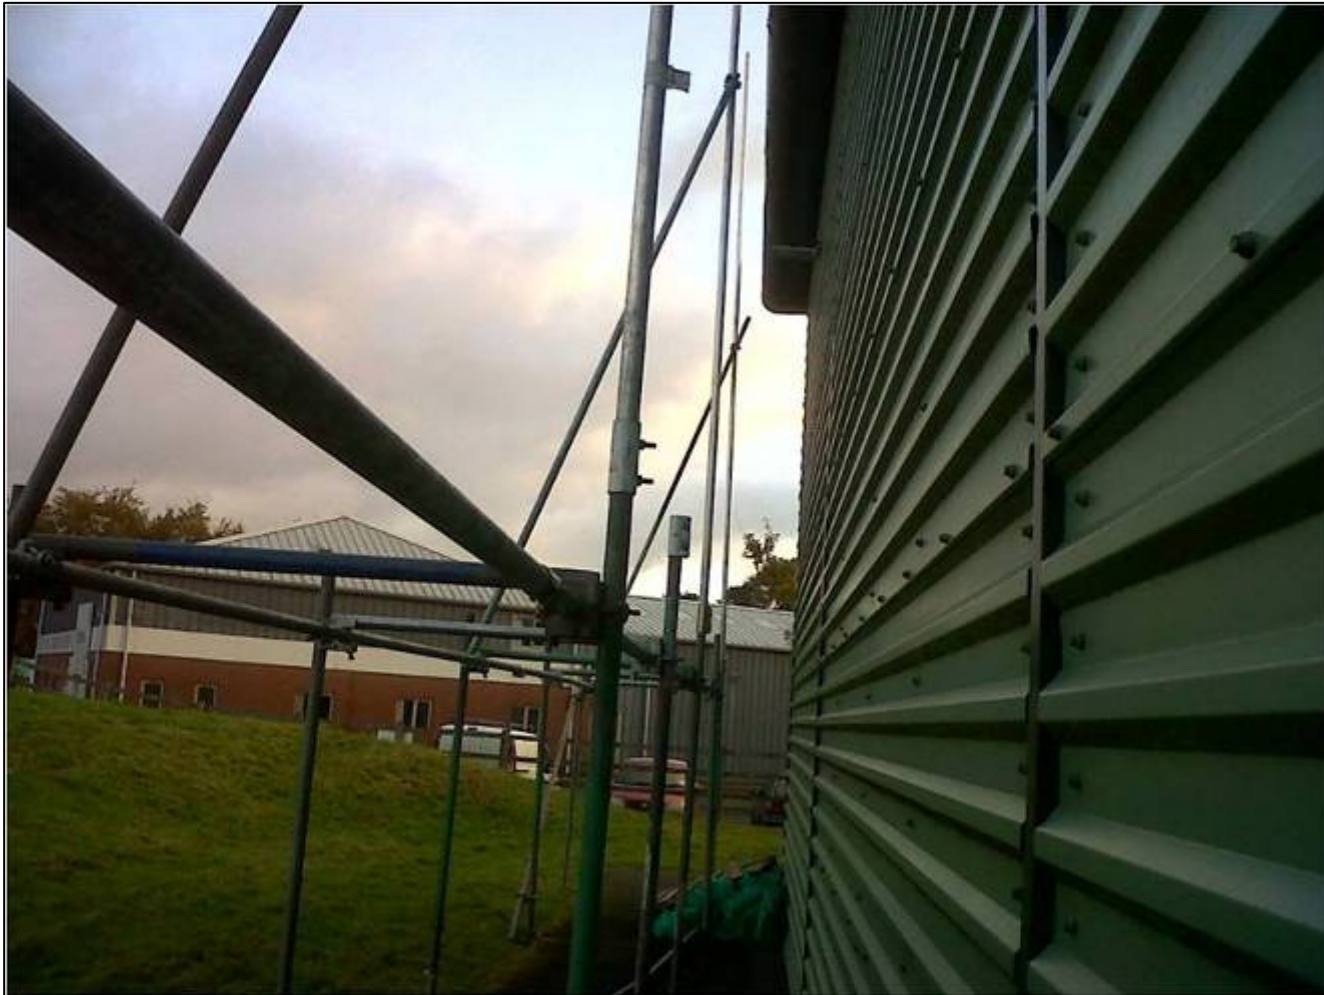
The scaffold that overturned was not a standard scaffold design as per TG20:08.

Without the kentledge in place there was the potential for the scaffolding to go over due to windy conditions.

Debris netting was installed at the request of the roofing contractors and scaffolder did not review the additional loading to see if the scaffold design was capable of taking the additional loads that could be imposed with wind.

The weather conditions would have had the potential to effect the stability of the scaffold.

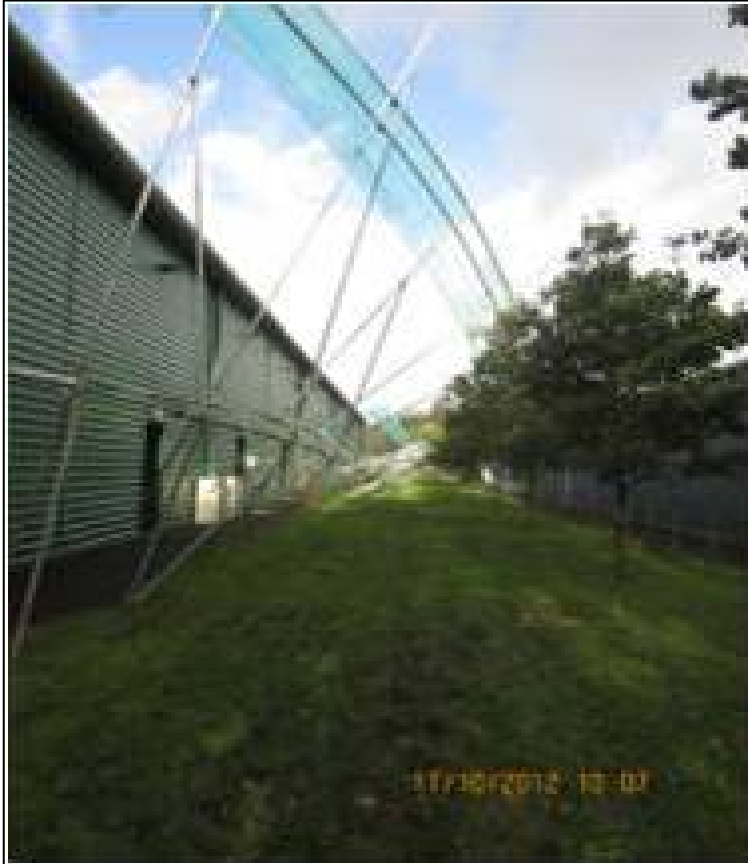
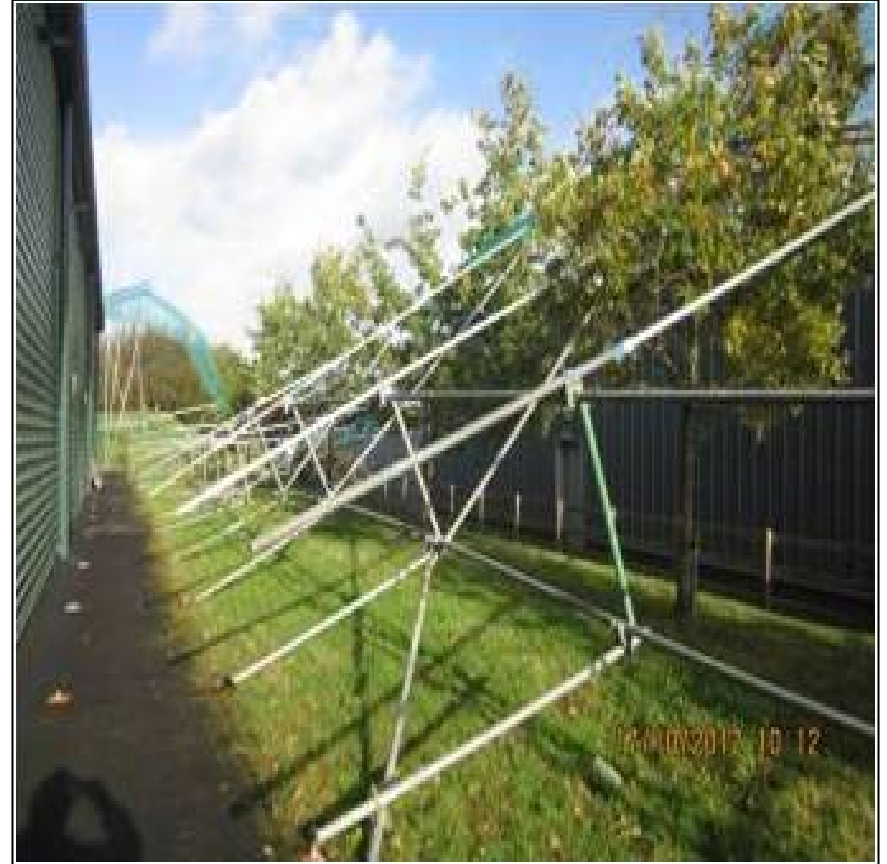
- There should have been sole pads under every standard inside and outside. The size of these sole pads should have been 225 by 450.
- The distance between the standards are too long and there should have been more standards in the scaffolding.

- There should have been a locking lift at the base of the standards. This would have provided more stability, added more weight to the scaffold and would have prevented the spread of the standards.

- There is no ledger bracing in any of the scaffolding. This should have been fixed on every other standard.
- There is inadequate face bracing on the scaffolding.

- Transoms should have been installed into that lift at every 1.2m centres and there should have also been extra transoms where the scaffolders have to butt the boards to give themselves a safe working platform.

- This clearly indicates the lack of transoms that the scaffolders have been working on dangerously over spanned scaffold boards.
- They have not been working to SG4:10.

Design to be in place that has been checked

Scaffolding installed to the design

Scaffolding erected in accordance with SG 4:10 now SG4:15
